**\*\*\* Residential Inspection Report \*\*\***

3582 Plymouth Ln  
Island Lake, IL, 60042

## Shield Inspect Inc

**Date Of Inspection:** March 15, 2018

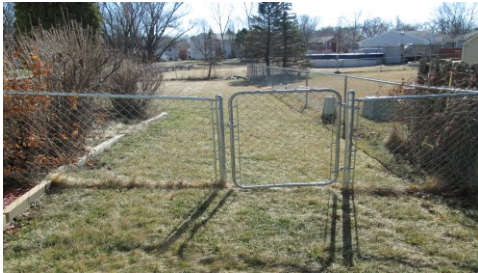
South side yard vegetation

**Further Comments:** • The ground on South side of the house appears to be too high against the foundation wall and siding. Foundation wall must be visible for at least 6 inches and a slope of at least one inch drop per foot away from the house is advised. That will avoid water pooling next to the foundation and work against. Some grading is recommended.

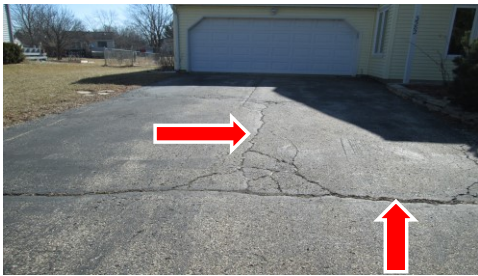
- Further Comments:**
- Asphalt driveway has stress/shrinkage/settlement cracks observed and noted.
  - There are few low areas on the driveway where water is pooling
  - Concrete walkway in front of the house has multiple cracks due to settlement and all gaps between walkway and foundation wall must be sealed .Uneven transitions driveway to walkway is noted . That is a trip hazard and safety hazard
  - All cracks/settlements noted must be kept under observation and repairs to me made if they become larger

Multiple cracks

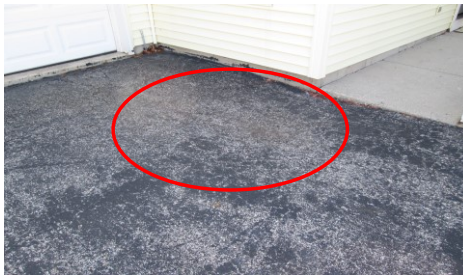
Low area where water is pooling

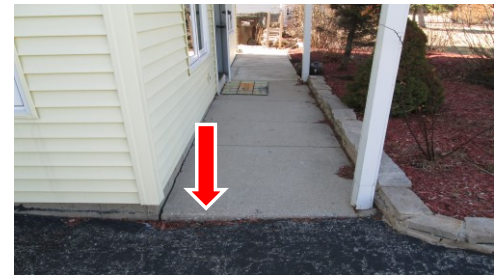
Trip hazard /uneaven transition

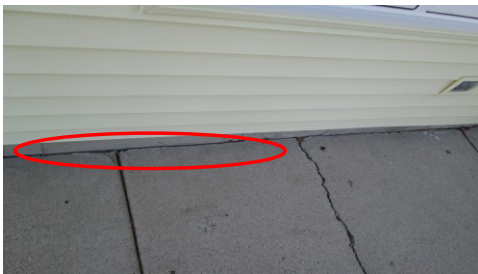
Gap between walkway and fundation

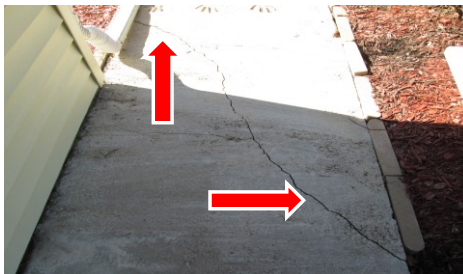
Crack on walkway

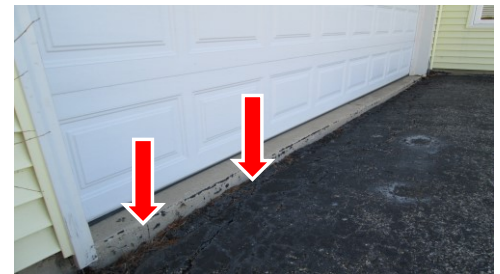
Low area where water is pooling

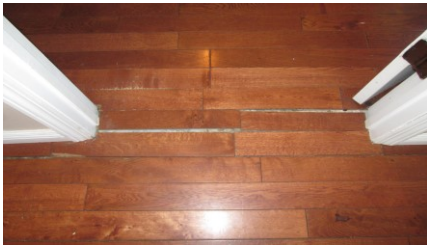
- Further Comments:**
- Every room and area of the house covered with hardwood floors is showing big cracks and separations of the boards: living room, first floor bedroom, upstairs hallways and both bedrooms. Repairs are needed
  - Where laminate flooring is installed ( dining room ) , floors are worn and repairs are also needed
  - Installation does not appear to conform to local standards
  - Failure to perform repairs may result in an unsafe condition
  - Recommend further evaluation by a qualified contractor

Big gaps/separations

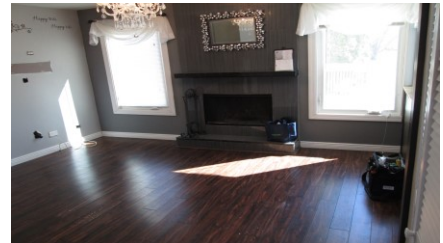
Worn floors

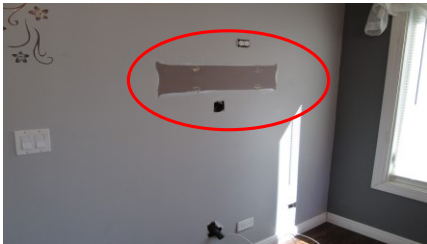
Further Comments: • Cosmetic repairs are needed in many areas of the house walls. There are holes, nails popping out, missing paint and also dirty spots throughout the entire house walls.

Wall damaged

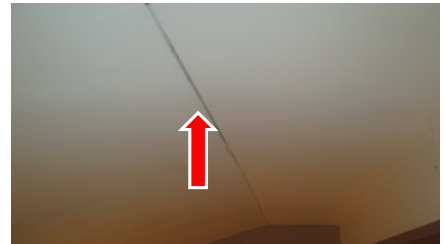
Crack

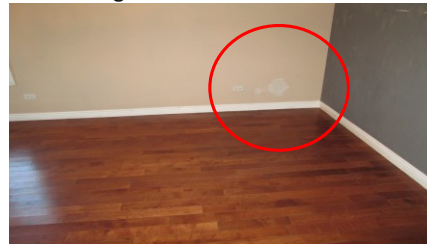
Missing paint

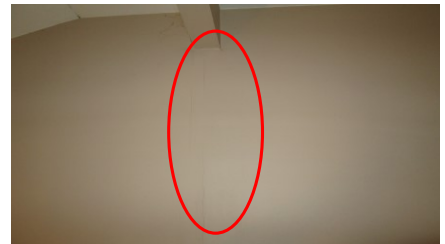
Crack

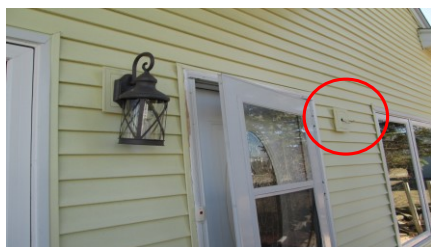
**Further Comments:** There still are some wall penetrations where sealant is needed to prevent water intrusion and feature damages to the house : vent outlet, outside wall faucet, AC condenser refrigerant lines

Siding penetrations

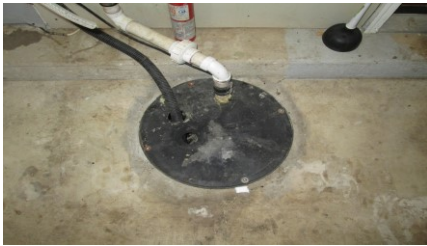
- Sump pump is not working. No electric connection .Suspicion of concealed defect and deficiency.
- Recommend further evaluation by a qualified contractor

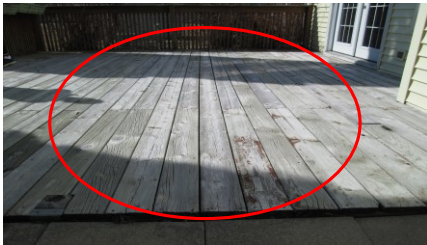
- Further Comments:
- Wood deck is visible damaged by age and weather. Some wood members are rotten and need to be replace.
  - Many of the deck vertical members ( spindels) are loose or needs to be resecured
  - Trip hazard noted at transition from wood deck to concrete pavers. Also many of those concrete pavers are broken and need to be replaced.
  - Failure to repair may cause additional damage and also may result in an unsafe condition .
  - Inspection by local building inspector recommended

Worn deck

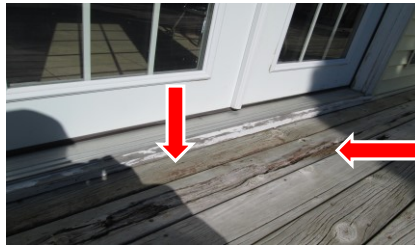
Rotten deck member

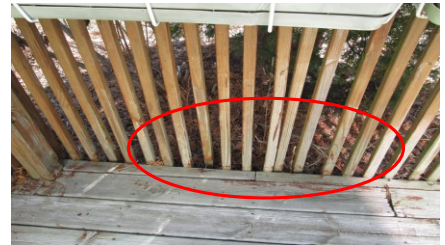
Loose guardrail mambers / unsecured

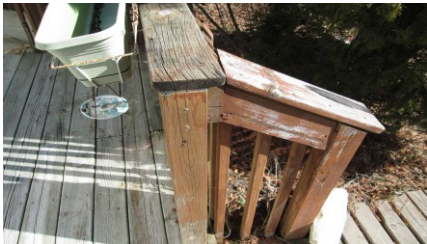
Worn guardrail

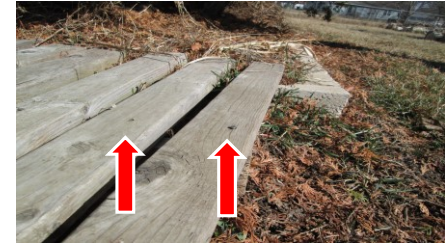
Nails popping . Safety Hazard

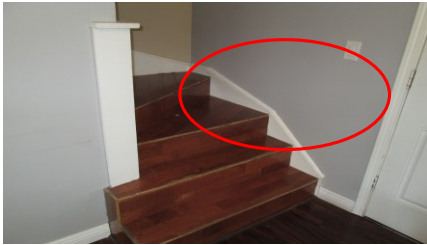
- Further Comments:**
- Stairs to second floor appears to be undersized and possible health hazard. They might not meet building codes and conform to local standards. Materials used are not suitable for application.
  - Handrail is missing at the bottom of the stairs . Grippable handrail is required if four or more risers
  - Existing handrail appears not to be tightly secured to wall and easy to grasp
  - Guardrail in upstairs hallway appears not to be strongly secured to walls and the space between spindels appears to be greater than four inches. That is safety and a child fall hazard .
  - Illumination is missing as well. A light with switch at top and bottom of the stairs is required when six or more risers.
  - Inspection by local building inspector recommended

Handrail missing

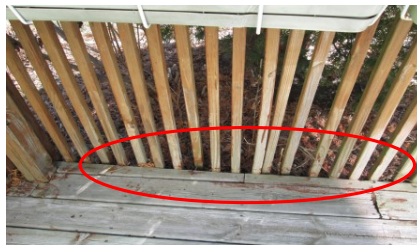
Loose and unsecured deck spindels

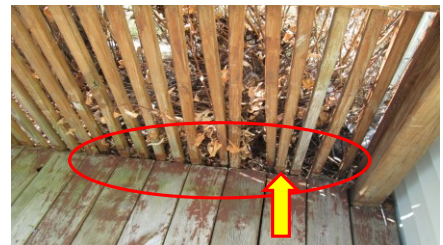
Loose and unsecured deck spindels

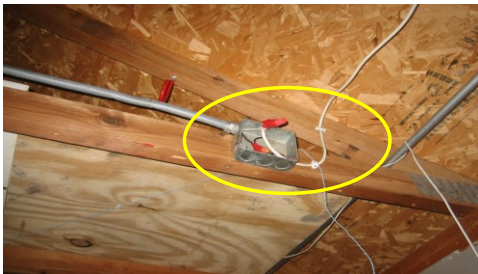
- Further Comments:**
- Worn Receptacle (s)and switch.
  - Open boxes and illegal wire connections for lighting
  - All garage receptacles need to be GFCI protected. Many of them are not and many of them are wrong wired .
  - Workmanship is unacceptable by current standards
  - Recommend further review and repairs from a local licensed or qualified professional A.S.A.P.
  - DANGER: FIRE HAZARD
  - DANGER: FIRE SAFETY HAZARD

Illegal connection and open box

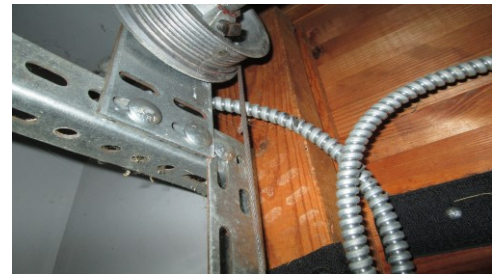
Loose armored cable BX

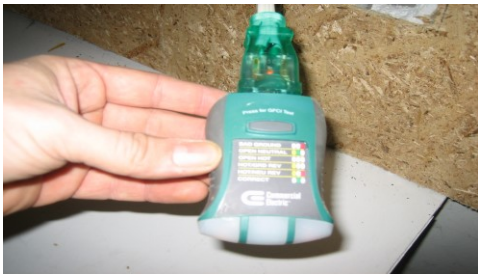
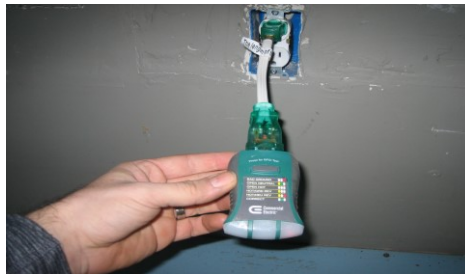
Open outlet/ no GFCI / bad ground

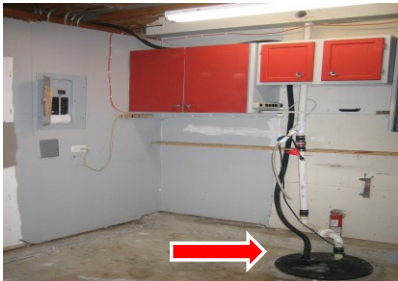
- Sump pump is located inside the garage. A white PVC pipe is raising and turns inside the house . Inspector was unable to identify the use of that pipe or where it leads or is connected to .Also the sump pump cover has openings and an unpleasant odor was emanating from water pit. It is inspector beliefs that the sump pump is not functional ( also not connected to electrical power). Further evaluation by an licensed plumber is recommended .

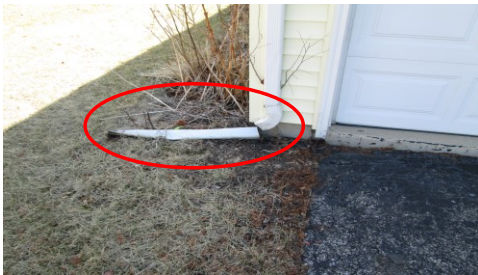
- Downspout at NW corner is damaged at ground level
- Downspout at SE corner is damaged at ground level
- Downspout at the W side should be redirected to discharge away and not along with the house
- Minor repairs and readjustments are needed

Broken downspout at ground level

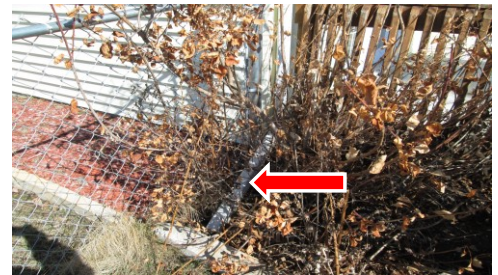
Broken downspout at ground level

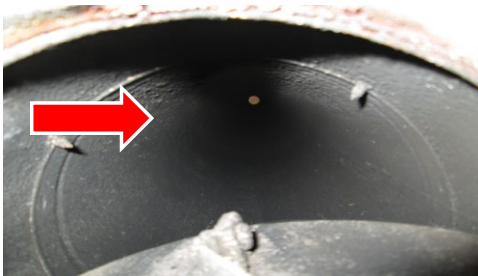
Flue

- Rust is present at the bottom of the flue pipe. There is also some signs of water intrusion .
- Further review from qualified professional is needed

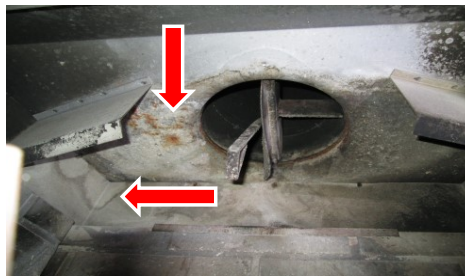
Rust and water marks

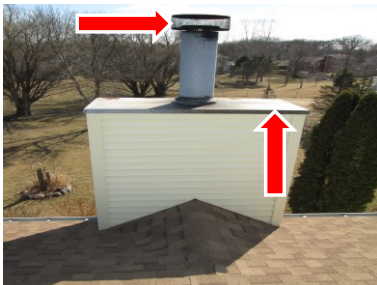
Chimney cap and spark arrester

- Improper and incomplete termination at chimney . There are gaps between the chimney metal cap and the chimney chase . Water has access inside the chimney . Repairs are needed .
- Further review from qualified professional is needed

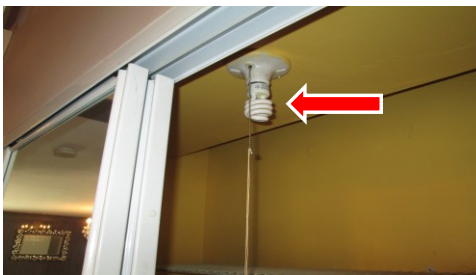
Light bulb cover is missing

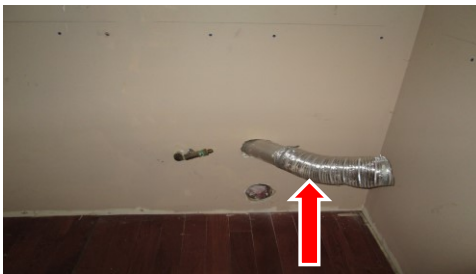
Exhaust vent in laundry room

- No dryer machine at the time of the inspection
- Backdraft demper is in poor connection with exhaust pipe and unapproved joint tape has been used.
- Workmanship is poor and repairs are needed before dryer will be installed .

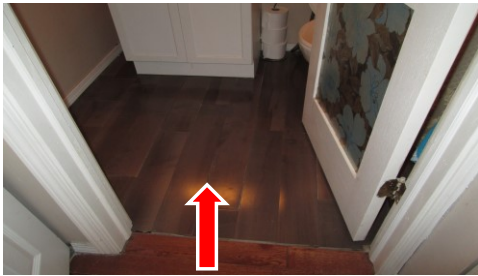
Bathroom floors

**Further Comments:** • Second floor Bathroom floor coverings are showing signs of water damage. This type of flooring is not suitable for such area and is prone to fast deterioration when in contact with water or high content of moisture .Workmanship is also poor, gaps and open spaces are noted. There is also a missing transition (threshold) at bathroom door. It is highly recommended for this floors to be changed with proper floor coverings for the area .

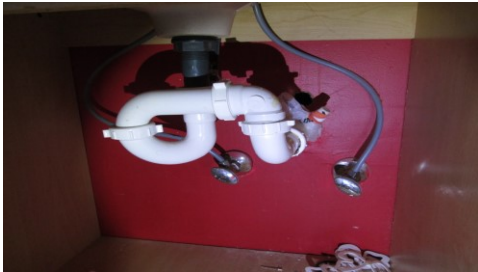
- Entire water supply and drain plumbing must be repaired at both bathrooms sink cabinets ! Repairs to be done following municipality Plumbing codes and requirements and only by an licensed plumber !
- Hot water temperature at the time of the inspection was set too high , showing more than 130 F at the bathroom outlet. That is an danger for scalding . A safe and acceptable hot water temperature in most cases and jurisdictions is 115 F-120F.
- At the time of the inspection, inspector noted that bathroom vent is venting inside attic and not outside the house. A venting connector was found disconnected in the attic. Venting inside an attic can result in bringing hot and humid air inside attic and that can lead to mold accumulations and feature damages to the house structure . This situation needs to be immediately corrected by a qualified professional !

Plumbing at it s worst !!!!!!!

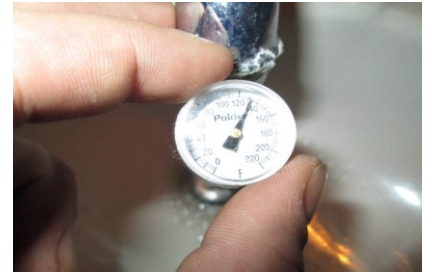
Hot water temperature is too high

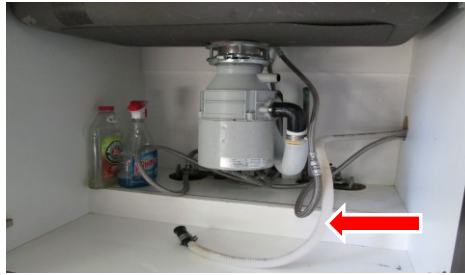
- The performance of the kitchen sink plumbing could not be tested at the time of the inspection. A food waste disposer is installed and dishwasher inlet was open and not connected to appliance .
- The food waste disposer was inoperative at the time of inspection
- Electrical and plumbing work and also materials used are substandard and repairs are needed . All repairs should be done by an qualified professional only and following municipaliy codes and requirements
- Some municipalities do not allow waste disposers based on the premise that these increase the load on municipal sewage treatment system.

Kitchen plumbing/loose connector

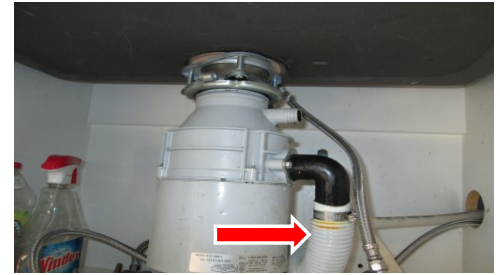
Kitchen plumbing/ flexible pipe

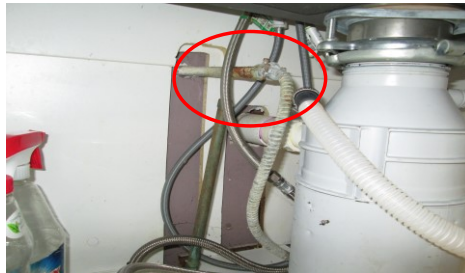
Wrong electric connection

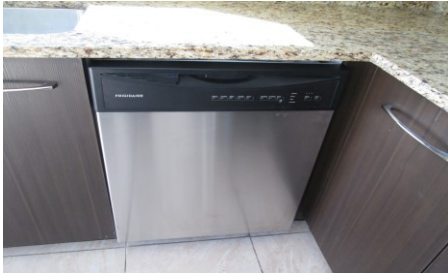
- Dishwasher was not working at the time of inspection .
- Inspector noted that dishwasher was not connected at electrical system and also the discharge drain pipe was also not connected to plumbing system
- Repairs are needed

Dishwasher not working

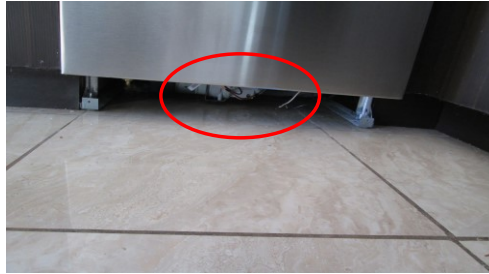
Dishwasher electric wires are loose

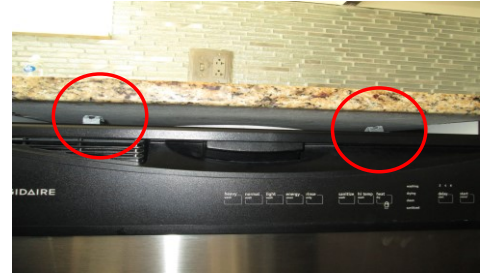
Not secured

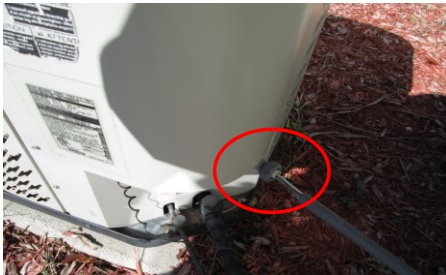
- AC condenser was inspected but could not be tested. Severe damage can occur to air conditioning compressors if they are turned on when outside temperature is below 65 F. Obtain seller statement if the cooling system is working or not !
- Insulations for refrigerant line is also damaged by weather and age . Replacement of insulation is recommended
- Exposed electrical wires are noted . Repairs are needed .

Exposed electric wires

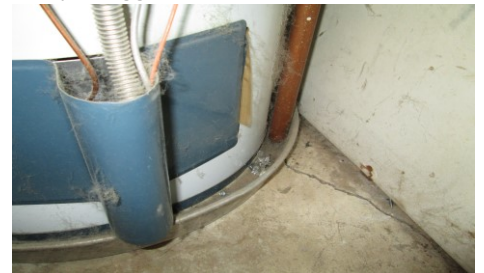
- Combustion air inlet is obstructed and clogged by dirt and can affect the performance of the water heater
- Hot water shut off is missing and recommended .
- Cleaning the location of the water heater and furnace is needed to avoid future fire risks and to ensure a normal performance of the appliances

Dirt around water heater parts
