**\*\*\* Residential Inspection Report \*\*\***

3582 Plymouth Ln  
Island Lake, IL, 60042

## Shield Inspect Inc

**Date Of Inspection:** March 15, 2018

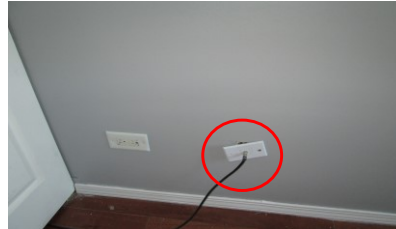
Unknown use of the switches

Loose cover plate

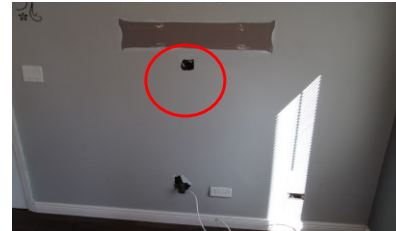
Hot-Neutral reversed

Open electric box

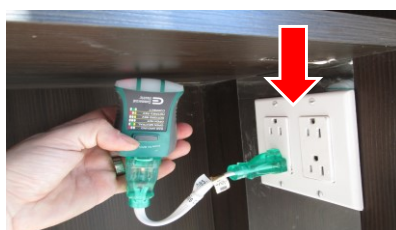
No GFCI protected/ bad wiring

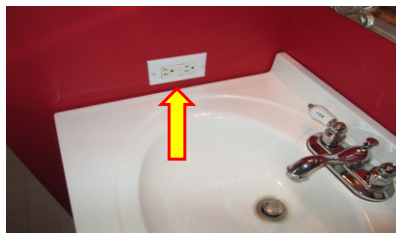
No GFCI and weatherproof cover

No GFCI / too close to water source

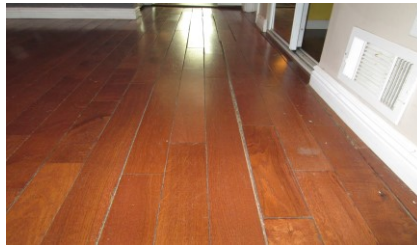
- Every room and area of the house covered with hardwood floors is showing big cracks and separations of the boards: living room, first floor bedroom, upstairs hallways and both bedrooms.Repairs are needed
- Where laminate flooring is installed ( dining room ) , floors are worn and repairs are also needed
- Installation does not appear to conform to local standards
- Failure to perform repairs may result in an unsafe condition
- Recommend further evaluation by a qualified contractor

Big gaps/ separations

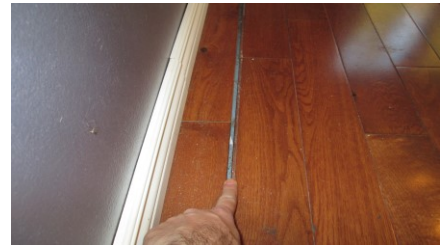
Big gaps/separation

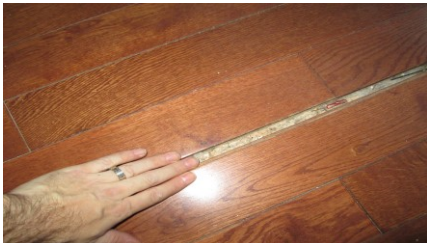
Big separation

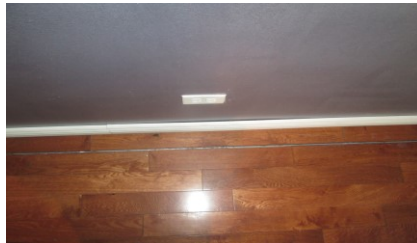
Big separation

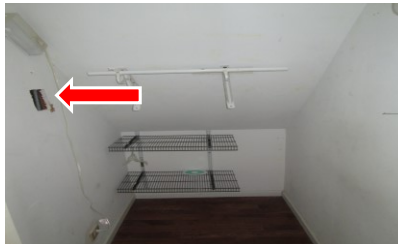
- Cosmetic repairs are needed in many areas of the house walls. There are holes, nails popping out, missing paint and also dirty spots throughout the entire house walls.

Wall damaged

Hole in wall

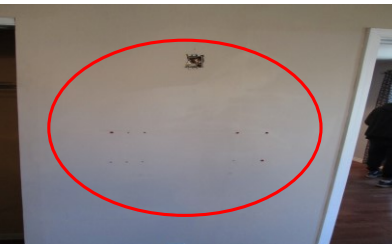
Missing paint

Holes

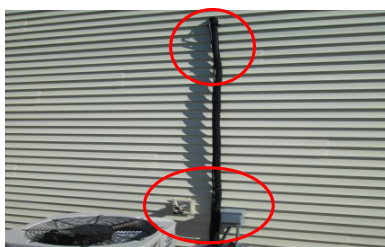
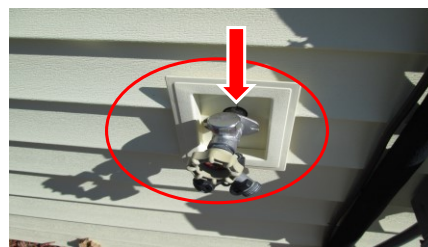
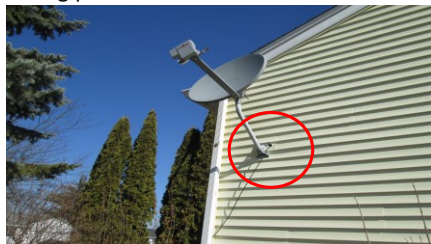
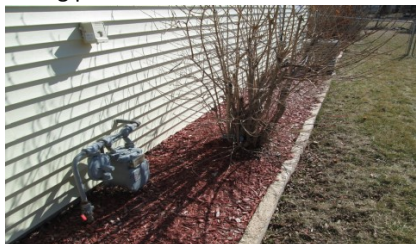
- There still are some wall penetrations where sealant is needed to prevent water intrusion and feature damages to the house : vent outlet, outside wall faucet, AC condenser refrigerant lines
- It is inspector belief that the siding material on SW walls was installed without proper support and manufacture specifications.
- This is a wood framed house and the wood sheeting on the SW corner appears to be missing . This is a major defect and can affect the integrity and functionality of the house .
- An invasive inspection throughout the exterior house walls by an local building inspector is strongly recommended .There is suspicion of concealed defects ! Contact owner and consult before further review !

Siding penetrations

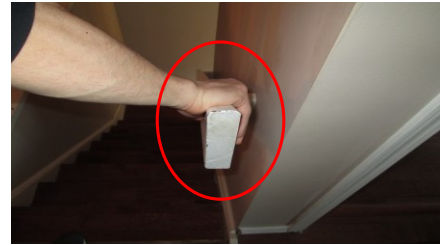
- Stairs to second floor appears to be undersized and possible health hazard. They might not meet building codes and conform to local standards. Materials used are not suitable for application.
- Handrail is missing at the bottom of the stairs . Grippable handrail is required if four or more risers
- Existing handrail appears not to be tightly secured to wall and easy to grasp
- Guardrail in upstairs hallway appears not to be strongly secured to walls and the space between spindels appears to be greater than four inches. That is safety and a child fall hazard .
- Illumination is missing as well. A light with switch at top and bottom of the stairs is required when six or more risers.
- Inspection by local building inspector recommended

Stairs appears to be undersized

Handrail hard to grab and hold

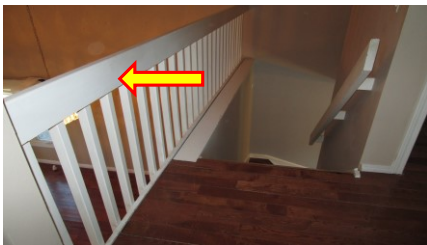
Guardrail not safe to lean on

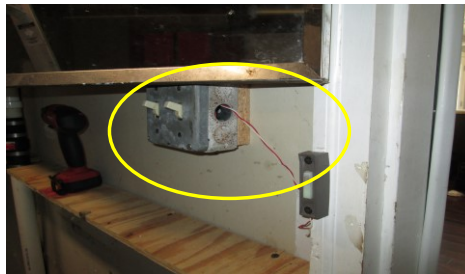
Illegal connection and open box

Illegal connection and open knockout

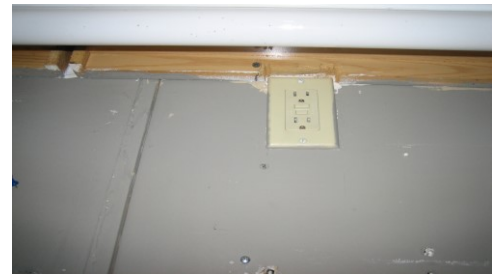
Open outlet/ no GFCI / bad ground

GFCI not working/ bad ground

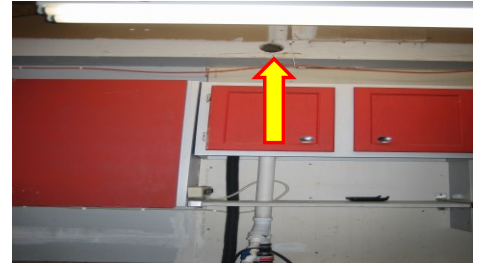
- There shall be no holes and not sealed gaps on the wall adjacent to home. Drywall needs to be fire rated .
- Immediate repairs are needed and done only by qualified professional.

Holes in garage-house common wall

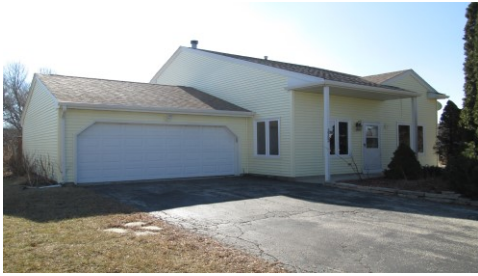
- Overhead garage door functional at the time of the inspection . All safety devices were functional .
- Door between garage and house has self closing device missing . Repairs are needed.
- Garage door on East wall is missing striker plate and does not open/close freely .Adjustments are needed

Overhead garage door

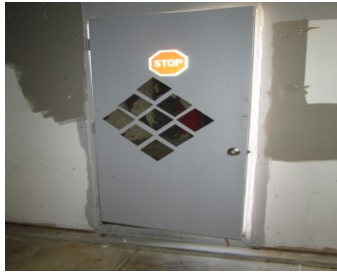
Man door on East wall

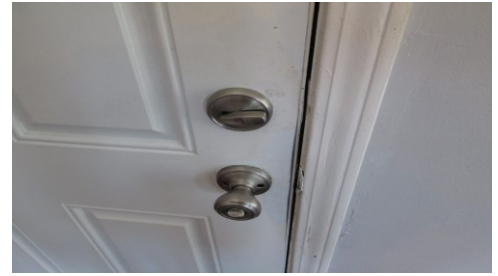
Man door between garage and home

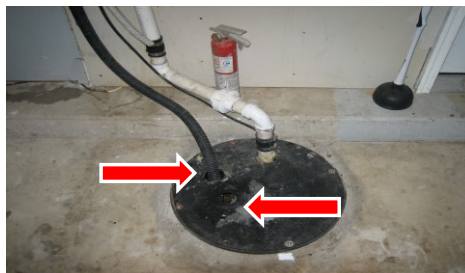
- Sump pump is located inside the garage. A white PVC pipe is raising and turns inside the house . Inspector was unable to identify the use of that pipe or where it leads or is connected to .Also the sump pump cover has openings and an unpleasant odor was emanating from water pit. It is inspector beliefs that the sump pump is not functional ( also not connected to electrical power). Further evaluation by an licensed plumber is recommended .

Sump pump with cover openings

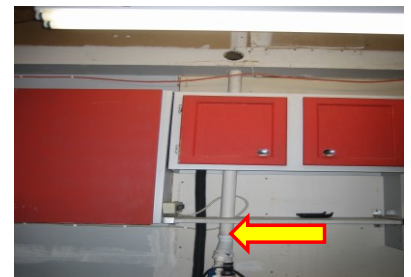
Unidentified use for PVC pipe

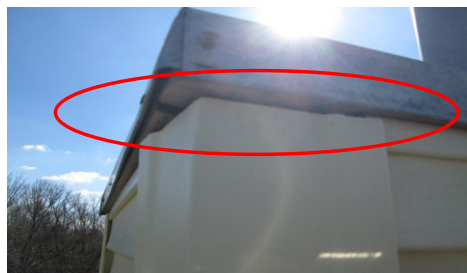
- Improper and incomplete termination at chimney . There are gaps between the chimney metal cap and the chimney chase . Water has access inside the chimney . Repairs are needed .
- Further review from qualified professional is needed

Unfinished Chimney top flashing

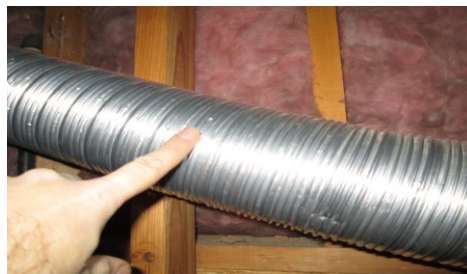
- No dryer machine at the time of the inspection
- Backdraft demper is in poor connection with exhaust pipe and unapproved joint tape has been used.
- Workmanship is poor and repairs are needed before dryer will be installed .

Dryer exhaust /negative pitch

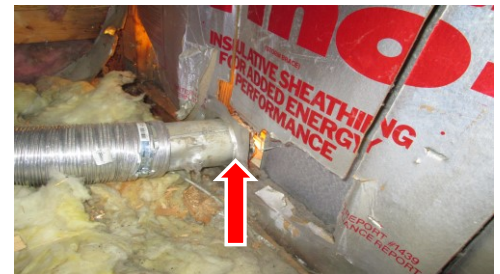
Dryer exhaust venting outside

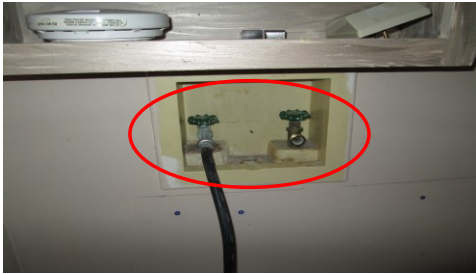
**Further Comments:** On site but not connected to washer and dryer . Could not be tested .

Washing machine water supply

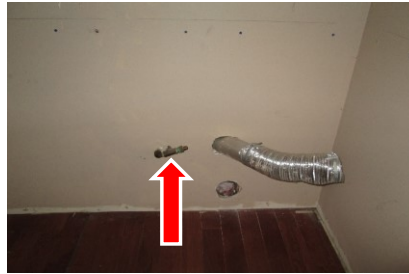
Gas supply pipe with shut off for dryer

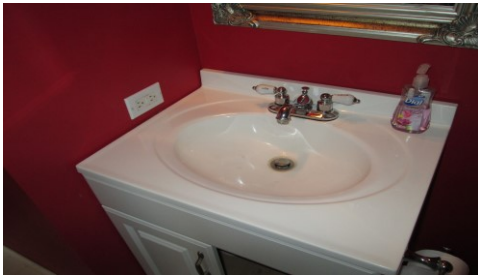
First floor bathroom sink cabinet

**Further Comments:** No concerns observed. Normal wear and tear signs

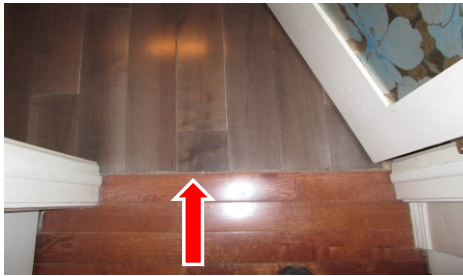
**Further Comments:** • Second floor Bathroom floor coverings are showing signs of water damage. This type of flooring is not suitable for such area and is prone to fast deterioration when in contact with water or high content of moisture .Workmanship is also poor, gaps and open spaces are noted. There is also a missing transition (threshold) at bathroom door. It is highly recommended for this floors to be changed with proper floor coverings for the area .

Gap at transition

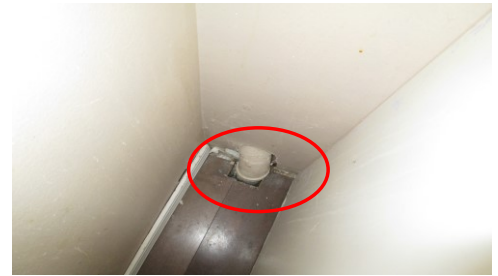
Every floor penetration must be sealed

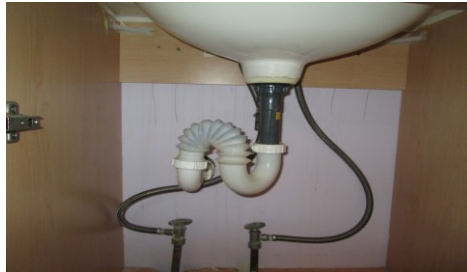
- Entire water supply and drain plumbing must be repaired at both bathrooms sink cabinets ! Repairs to be done following municipality Plumbing codes and requirements and only by an licensed plumber !
- Hot water temperature at the time of the inspection was set too high , showing more than 130 F at the bathroom outlet. That is an danger for scalding . A safe and acceptable hot water temperature in most cases and jurisdictions is 115 F-120F.
- At the time of the inspection, inspector noted that bathroom vent is venting inside attic and not outside the house. A venting connector was found disconnected in the attic. Venting inside an attic can result in bringing hot and humid air inside attic and that can lead to mold accumulations and feature damages to the house structure . This situation needs to be immediately corrected by a qualified professional !

Bad plumbing !!!!!

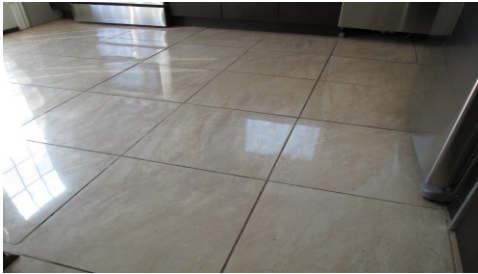
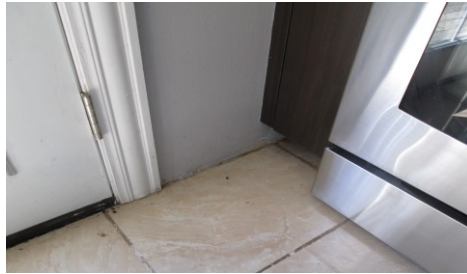
Kitchen floors

**Further Comments:** No major concerns observed but some cosmetic repairs are needed .

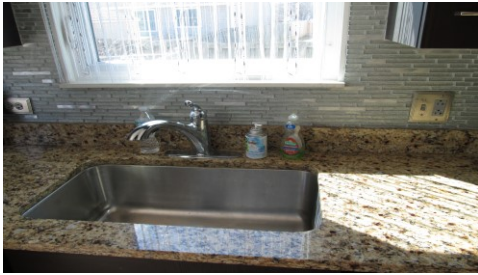
Kitchen sink

- The performance of the kitchen sink plumbing could not be tested at the time of the inspection. A food waste disposer is installed and dishwasher inlet was open and not connected to appliance .
- The food waste disposer was inoperative at the time of inspection
- Electrical and plumbing work and also materials used are substandard and repairs are needed . All repairs should be done by an qualified professional only and following municipaliy codes and requirements
- Some municipalities do not allow waste disposers based on the premise that these increase the load on municipal sewage treatment system.

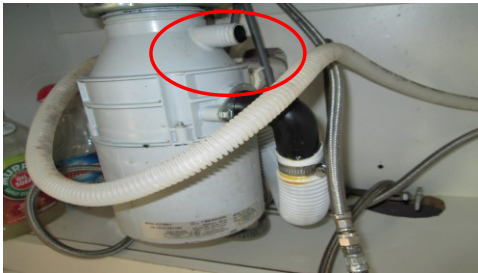
No connection / open water outlet

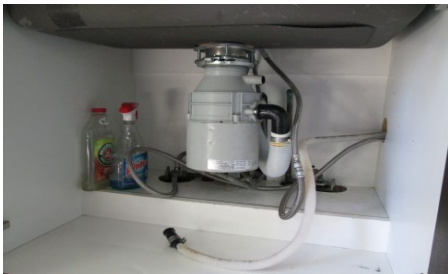
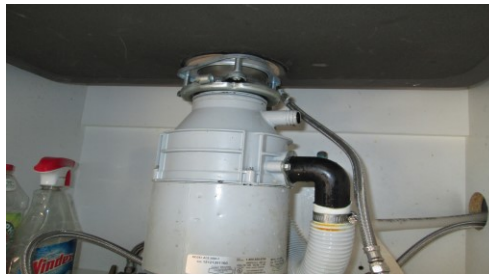
Food waste disposer

- The condition of the food waste disposer was described before at Kitchen/ sink section .

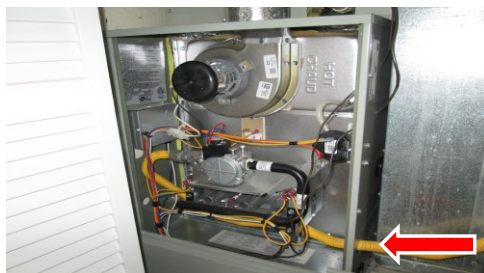
- At the time of the inspection furnace was operational .
- Inspector noted that the supply gas pipe to furnace is flex pipe. It is well known that flex connectors shall not be extended through walls,floors, partitions, ceilings or appliance housings.
- There is a chance that this thin wall flex pipe can be cut by the sharp edge of the furnace housing which could cause a gas leak or worse !
- 
- Further review from qualified professional is needed since un approved gas pipe was used and with no safety devices ( gromets) at penetration.
- Furnace filter is also dirty. Filters protect the furnace keeping it clean and help maintain good air quality throughout the house

Flex pipe gas supply at furnace

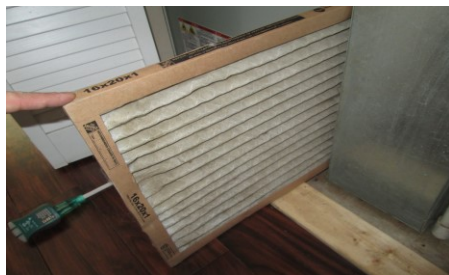
Dirty filter

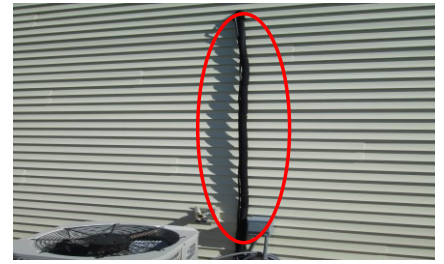
- AC condenser was inspected but could not be tested. Severe damage can occur to air conditioning compressors if they are turned on when outside temperature is below 65 F. Obtain seller statement if the cooling system is working or not !
- Insulations for refrigerant line is also damaged by weather and age . Replacement of insulation is recommended
- Exposed electrical wires are noted . Repairs are needed .

Refrigerant lines are weathered

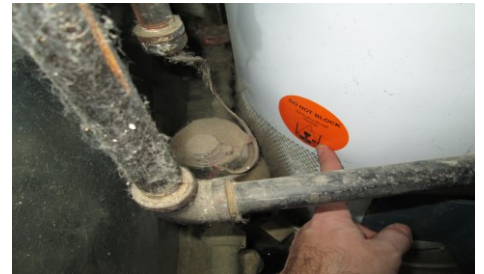
- Combustion air inlet is obstructed and clogged by dirt and can affect the performance of the water heater
- Hot water shut off is missing and recommended .
- Cleaning the location of the water heater and furnace is needed to avoid future fire risks and to ensure a normal performance of the appliances

Dirty /clogged air inlet

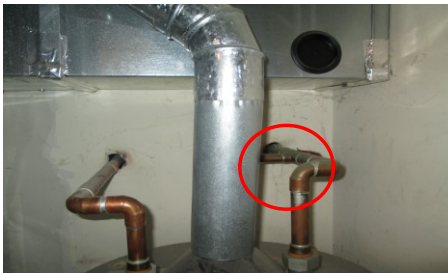
Cold water shut off

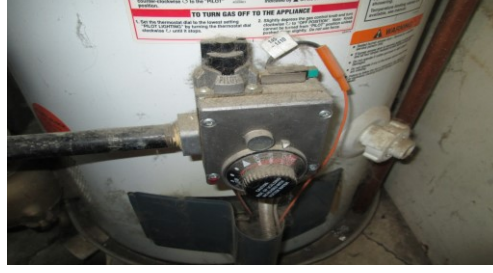
Dirty thermostat and gas valve
